NATIONAL AERONAUTICS AND SPACE ADMINISTRATION

APOLLO 10 MISSION REPORT

MANNED SPACECRAFT CENTER

AUGUST 1969

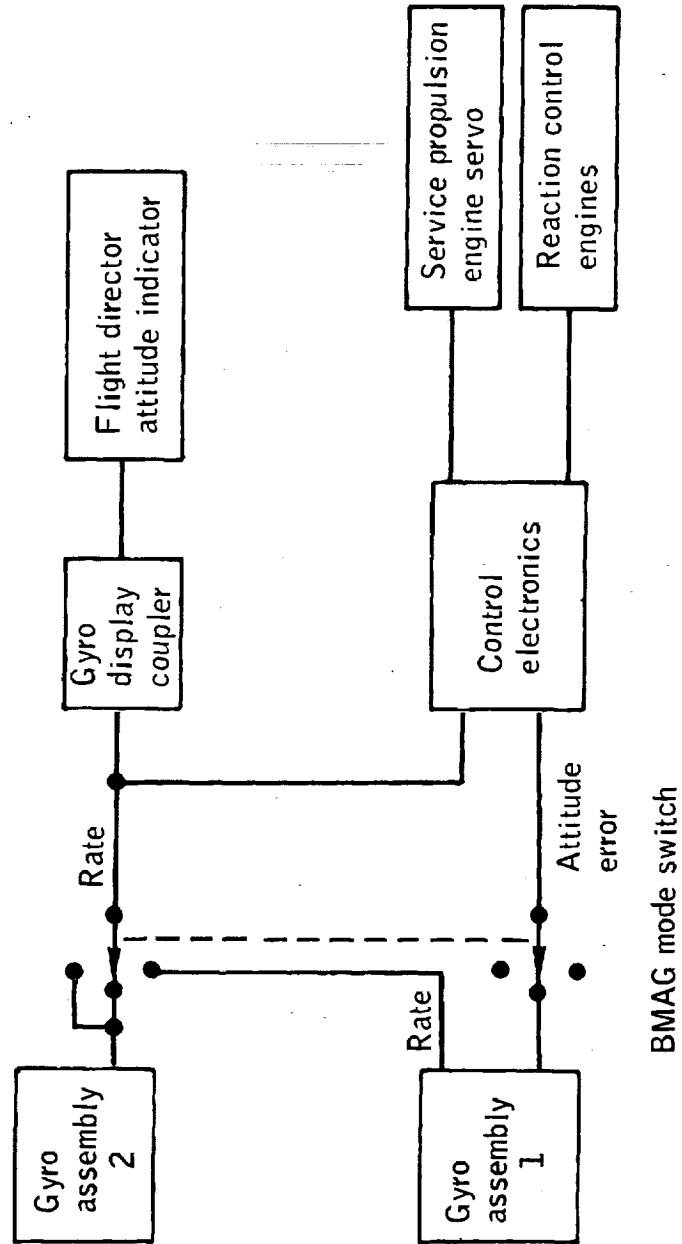
Figure 15-9.- Stabilization and control system.

A simplified block diagram of the stabilization and control system showing the functions of the gyro display coupler and the spacecraft control loops is shown in figure 15-9. One of the two gyro assemblies provides only rate information and is normally used to drive the gyro display coupler. The other gyro assembly can provide either rate or attitude error, at crew option, and can be selected to drive the gyro display coupler.

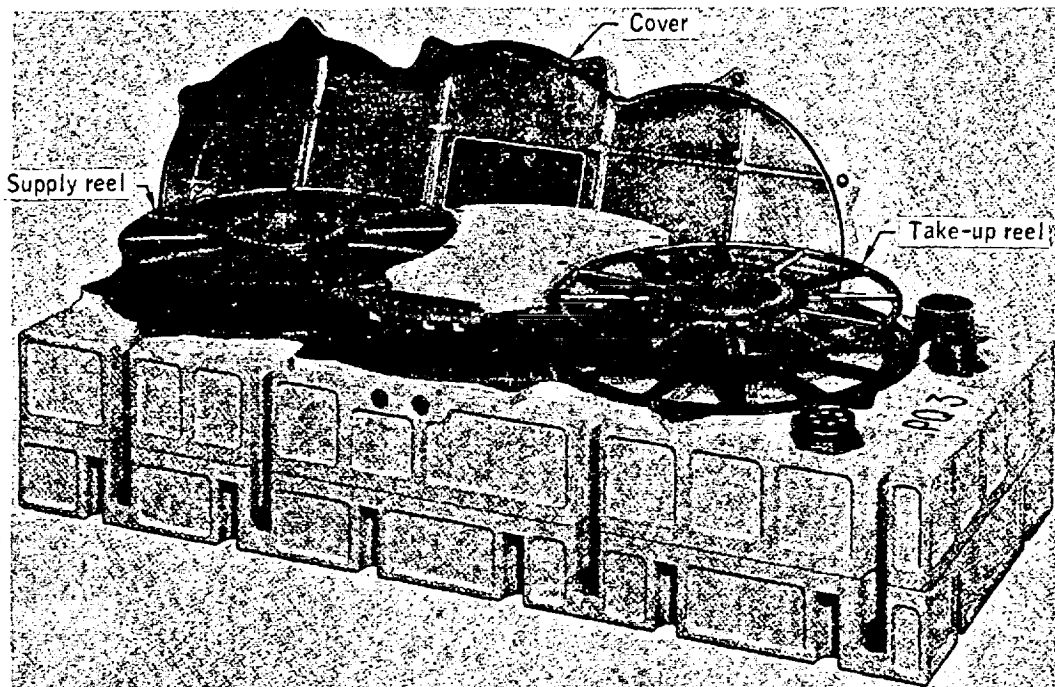
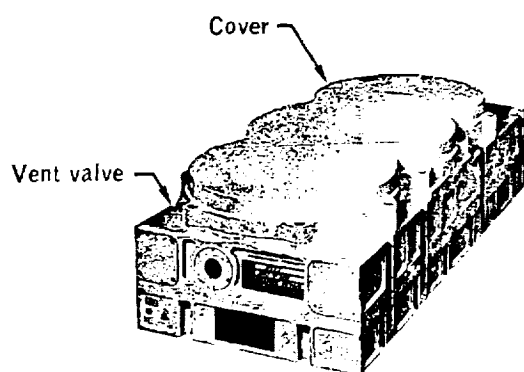
Figure 15-10.- Data storage equipment.

Testing of the recorder has revealed that an outside-to-inside pressure differential of 2.25 psi is sufficient to deform the cover, causing it to contact the tape reels (fig. 15-10).

Clearance between cover
and reel hubs is 0.058
to 0.053 in.

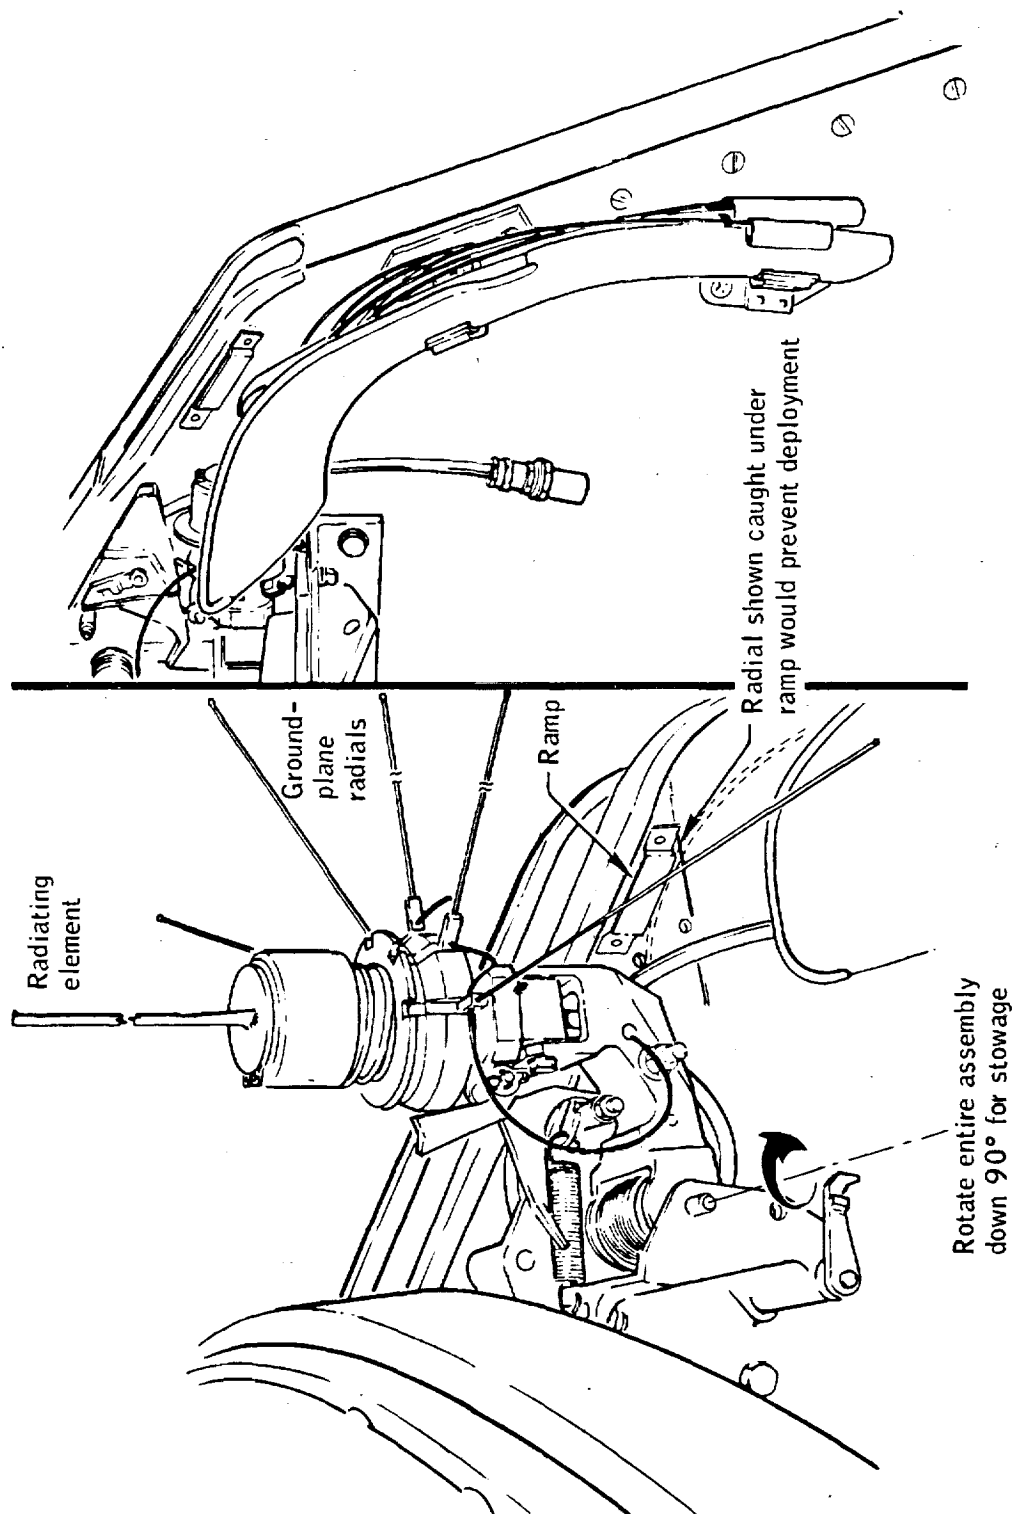
Figure 15-11.- VHF recovery beacon antenna deployed.

The antenna did not deploy because one radial was caught under the outboard edge of the ramp shown in figure 15-11.

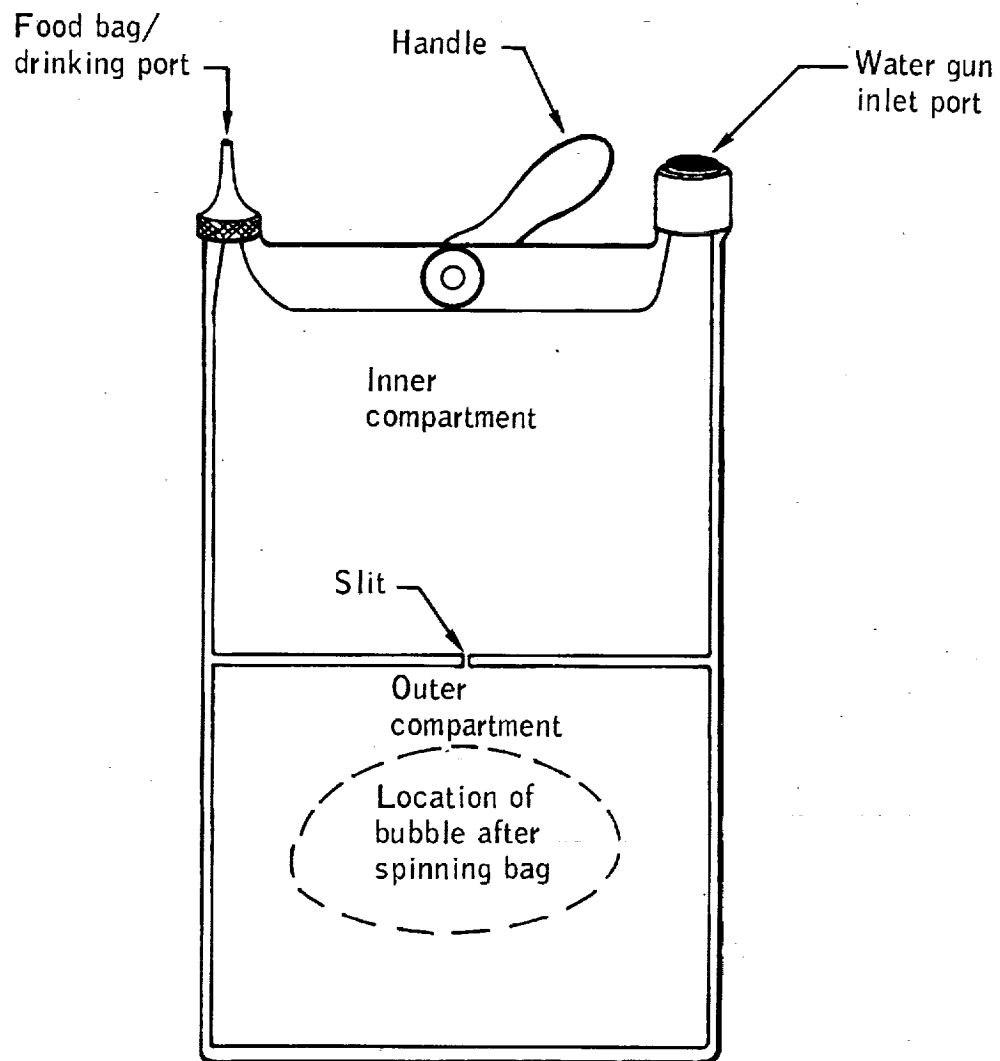
Figure 15-12.- Water/gas separation bag.

To alleviate the problems, a two-compartment bag with a handle for whirling the bag in a circular motion was provided (fig. 15-12). This bag had been developed rapidly with insufficient time for a complete test program. It did not function as intended in flight.

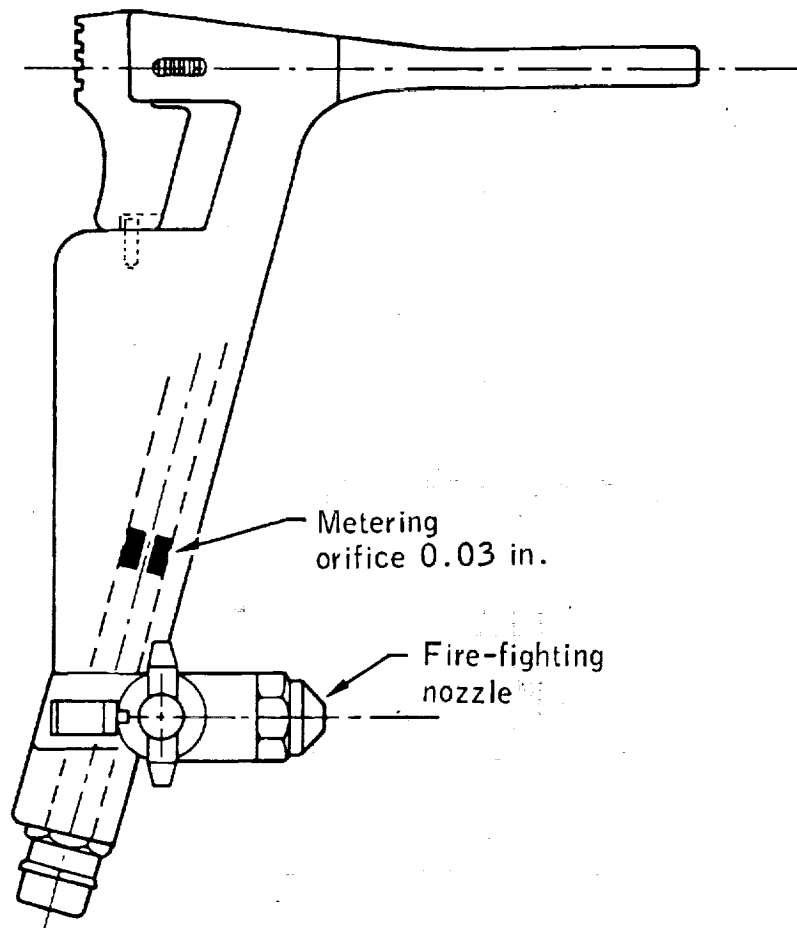
Figure 15-14.- Water gun.

For about 2 hours on the seventh day of the flight, the flow from the command module water dispenser appeared to be less than normal. An 0.03-inch orifice within the dispenser normally limits flow to approximately 6 cc/sec (see fig. 15-14). A reduction in flow at the food preparation panel could not be verified. The driving force for the water is oxygen at 20 psia, and this pressure was normal. Also, the crew reported that the hose was not kinked.

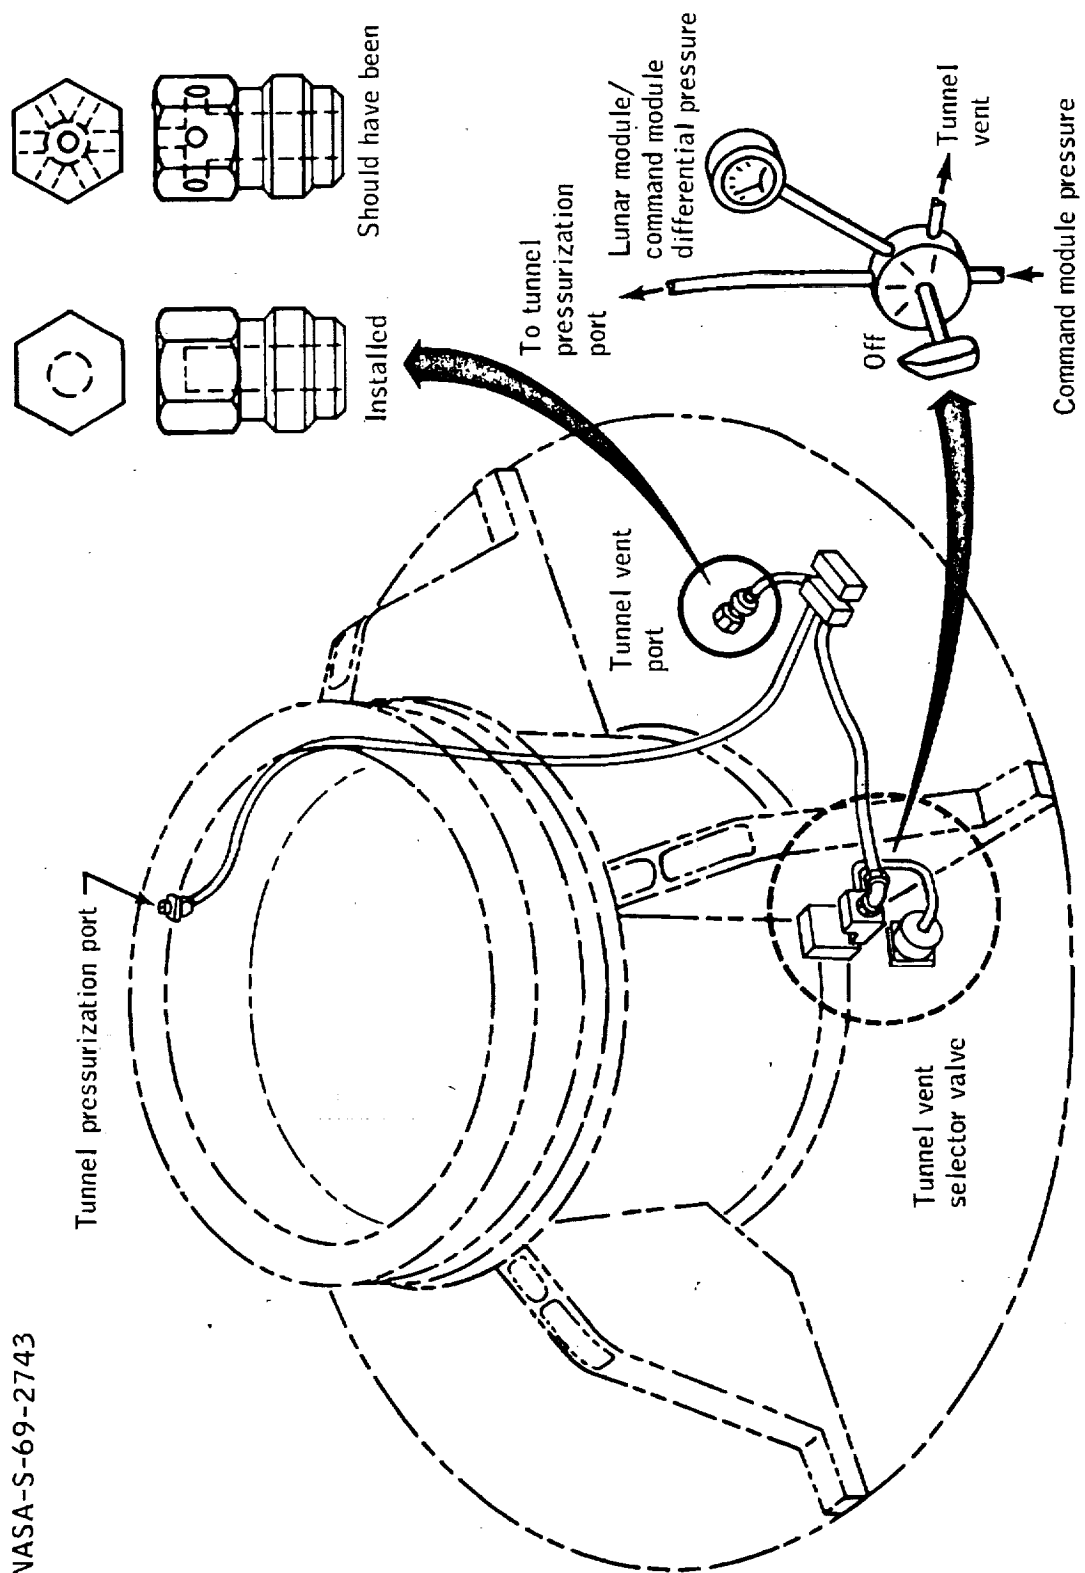
Figure 15-15.- Tunnel vent system.

system. Postflight inspection of the vent system revealed that an incorrect fitting had been installed on the vent (fig. 15-15). The proper part was specified in the installation procedures.

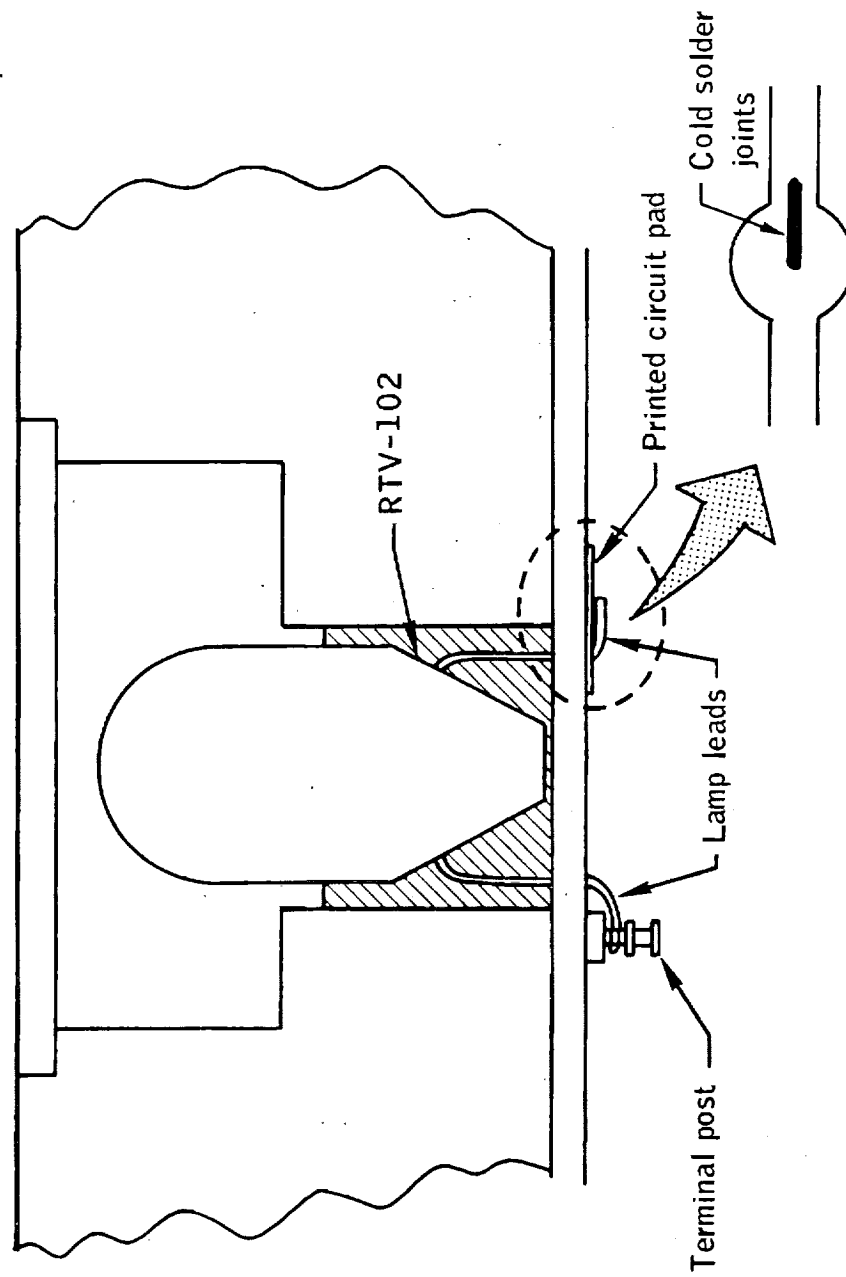
Figure 15-17.- Lamp assembly.

were found where the lamp lead was attached to the printed circuit board (fig. 15-17). The cold-solder joint would have caused intermittent lamp operation.

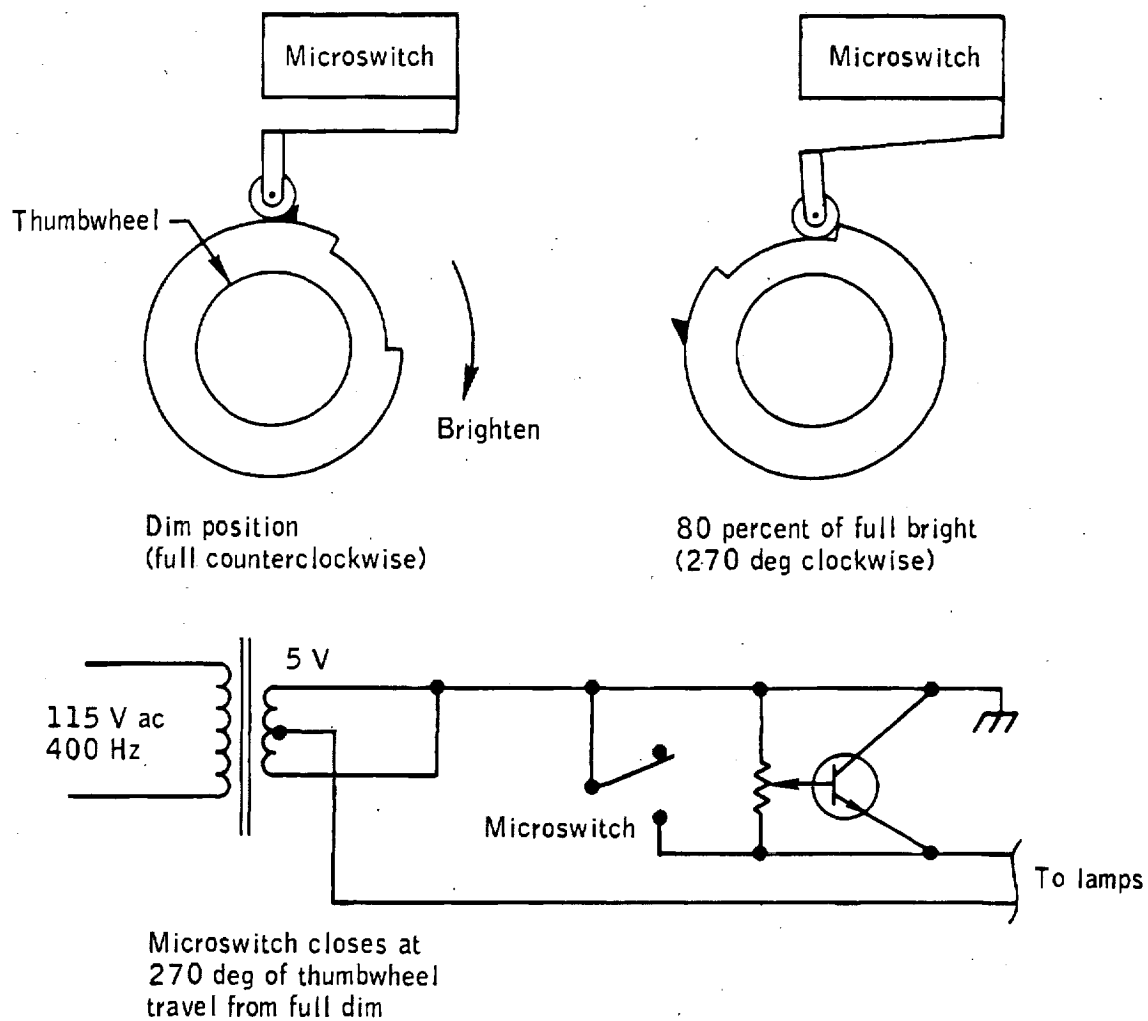
Figure 15-29.- Optics reticle dimmer.

The thumbwheel operates a variable resistor through a shaft/cam mechanical interface (fig. 15-29). Frictional force generated by the arm of the microswitch is present from the fully counterclockwise position (full dim) through 270 degrees of clockwise rotation (80 percent brightness). The typical torque required to overcome the frictional force in the 270-degree sector is 1.5 inch-ounces. When the microswitch depresses into the 60-degree detent area of the cam, the frictional force decreases. Although the thumbwheel can rotate through an additional 60 degrees, reticle brightness is not changed, since the microswitch has bypassed potentiometer control of the circuit and has applied full voltage to the reticle lamps (fig. 15-29). In the depressed area of the cam, any motion imparted to the thumbwheel will continue until the mechanical stops of the variable resistor are reached. This feature increases the reliability of the reticle lamp control by including a mechanical override that will assure reticle brightness if an electrical component fails.

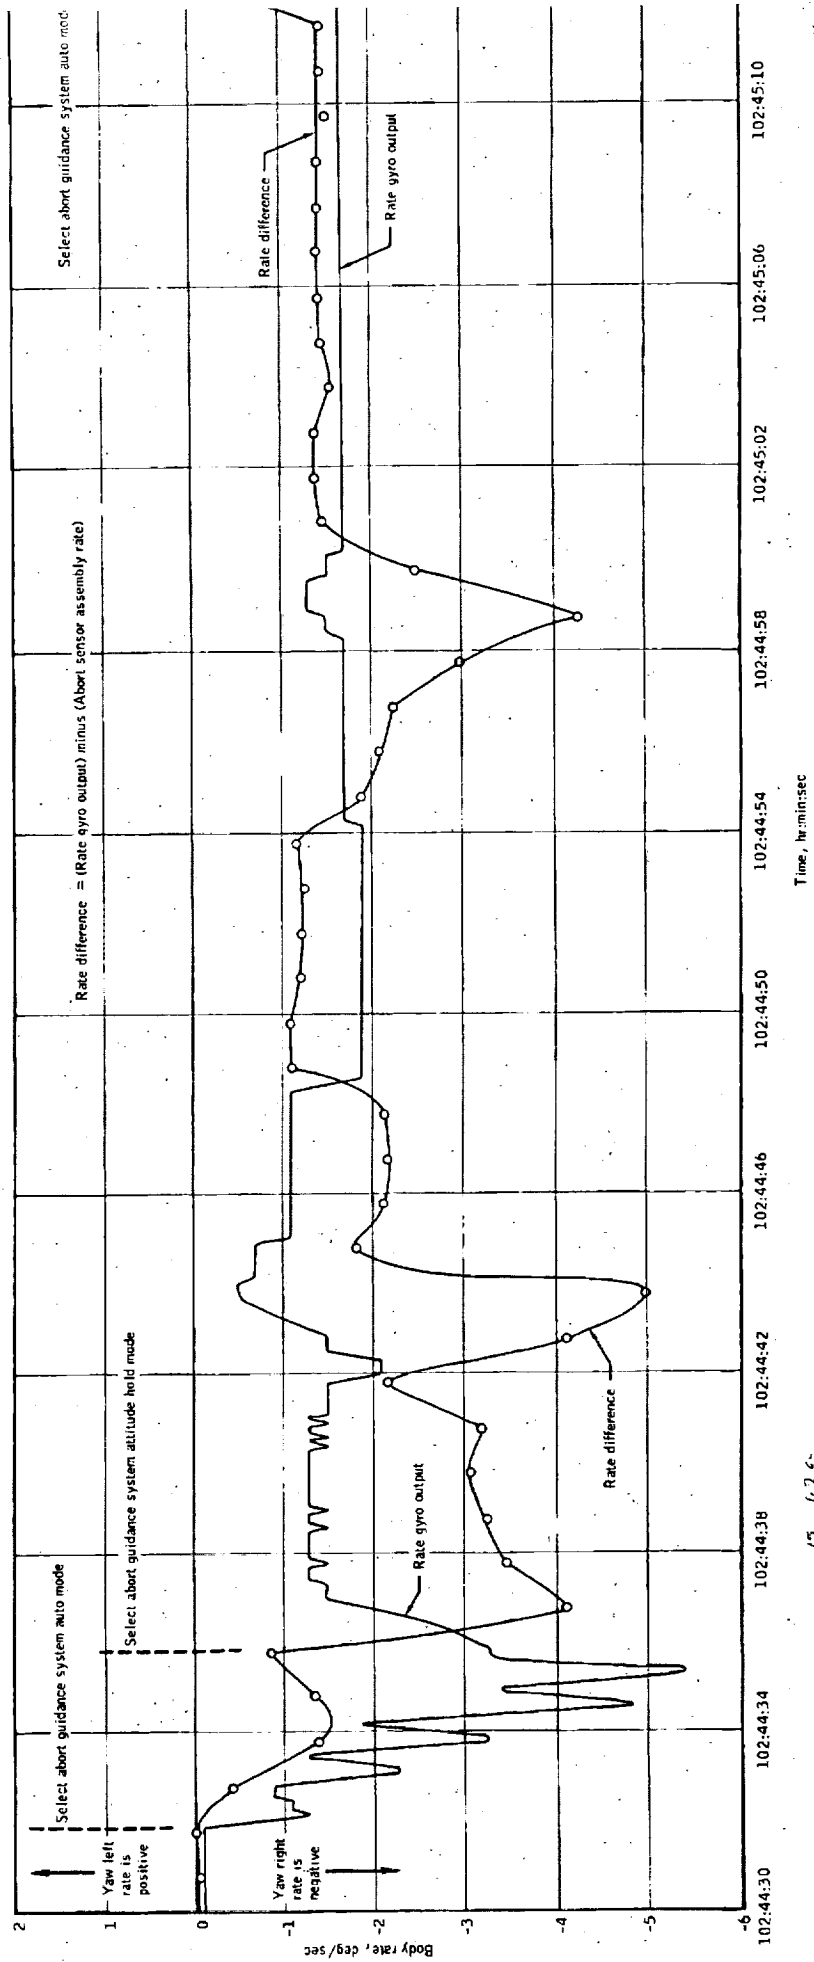
Figure 15-30. - Rate gyro output and output error.

The yaw rate gyro output differed from actual yaw rate during the 50-second period before staging and several seconds after staging. Figure 15-30 contains a time history of the difference between the rate gyro output and actual vehicle rate as computed from attitude data. No evidence of abnormal operation has been found before or after this period. The rate gyro torquing test performed prior to undocking was normal.

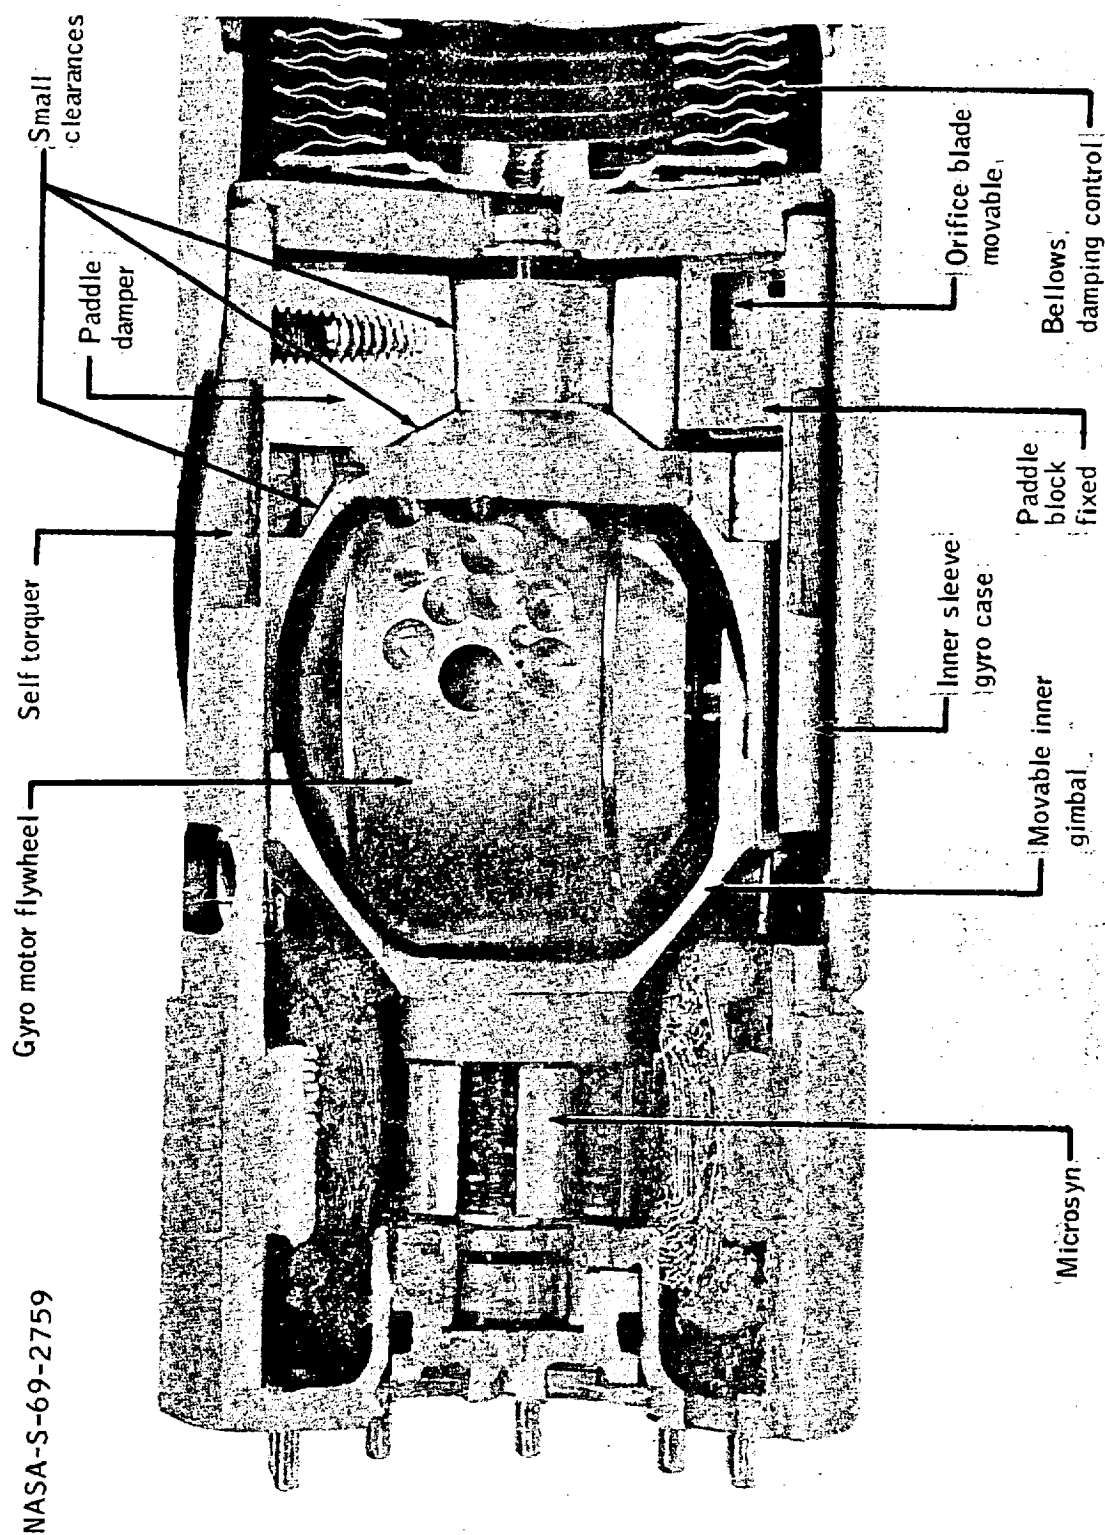
Figure 15-31.- Cross sectional view of rate gyro.

The rate gyro is a spring-restrained, single-degree-of-freedom unit with the spring force being supplied by a torsion bar (fig. 15-31). The wheel assembly is partially floated in a silicon damping fluid. Damping is supplied by a paddle wheel which pumps fluid through a temperature-controlled orifice. Three gyros are mounted orthogonally in a rigid block and placed in the spacecraft such that each gyro input axis is parallel to a spacecraft axis.

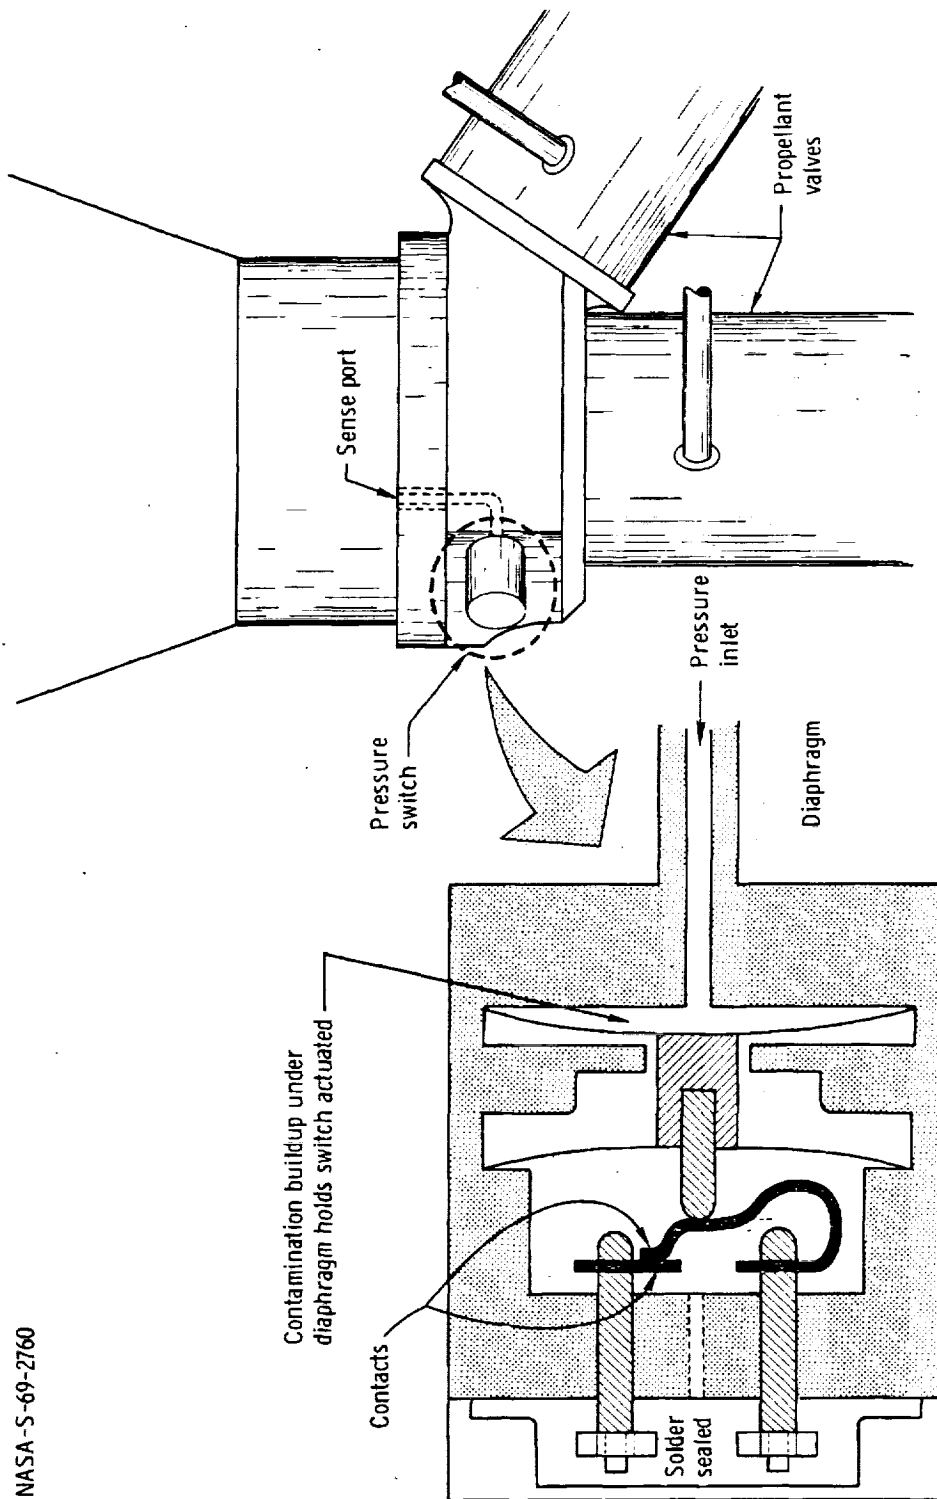
Figure 15-32. - Lunar module reaction control system thrust chamber switch.

The failure mode for these five switches is believed to be the same as that of one LM-3 unit and several others during ground testing. Particulate contamination and/or propellant residue is forced under the switch diaphragm by chamber pressure and holds the diaphragm deflected and the electrical contacts closed (fig. 15-32). The small stroke of the diaphragm (0.007 inch) and the low diaphragm restoring force generated by the return spring make the switch extremely susceptible to failure by contamination.

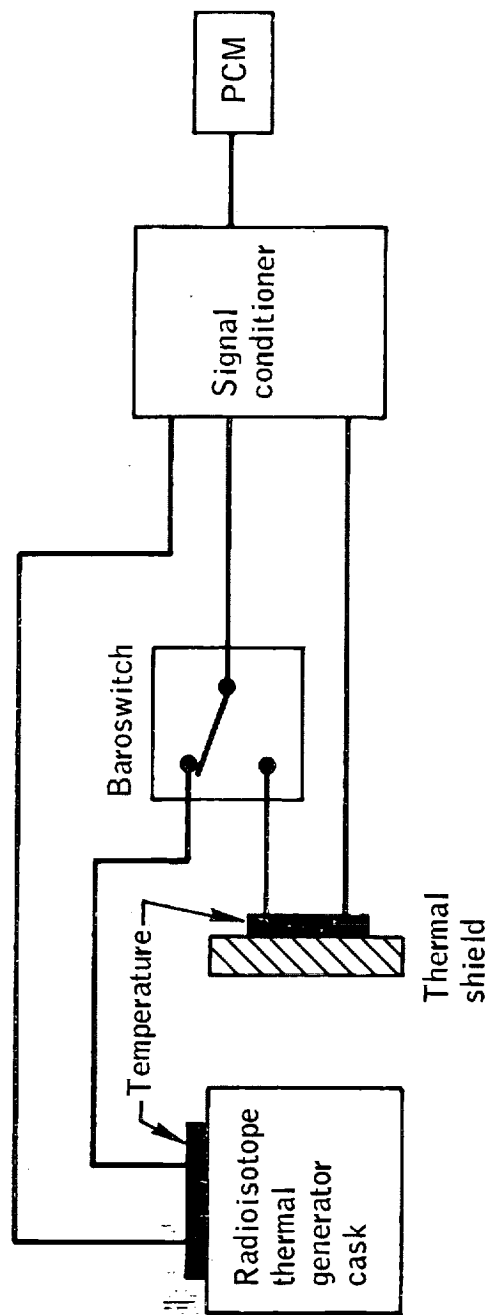
Figure 15-33.- Cask temperature.

Cask thermal shield temperature.- The temperature measurement of the thermal shield for the radioisotope thermal generator cask read upper limit throughout the lunar module portion of the flight. The telemetry is switched to this measurement from cask temperature by a baroswitch at 10 000 foot altitude (fig. 15-33).

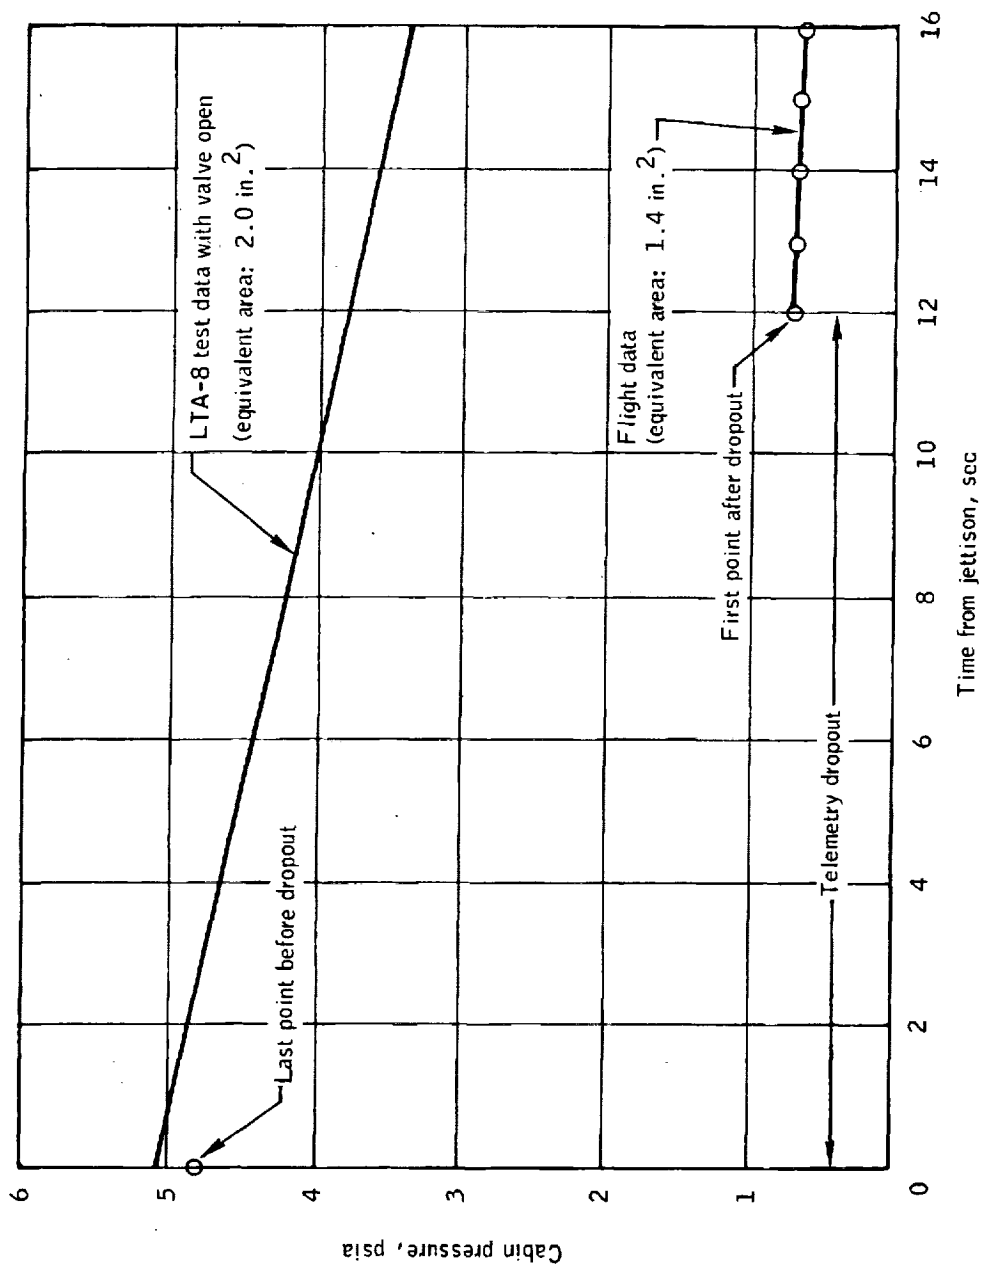
Figure 15-34.- Measured cabin pressure during jettison.

In summary, the analyses indicate that the loading on the lunar module hatch at separation exceeded the capability of the latch. The hatch then opened and closed resulting in a cabin pressure decay as shown in figure 15-34 and separation distance and relative accelerations as shown in figures 15-35 and 15-36.

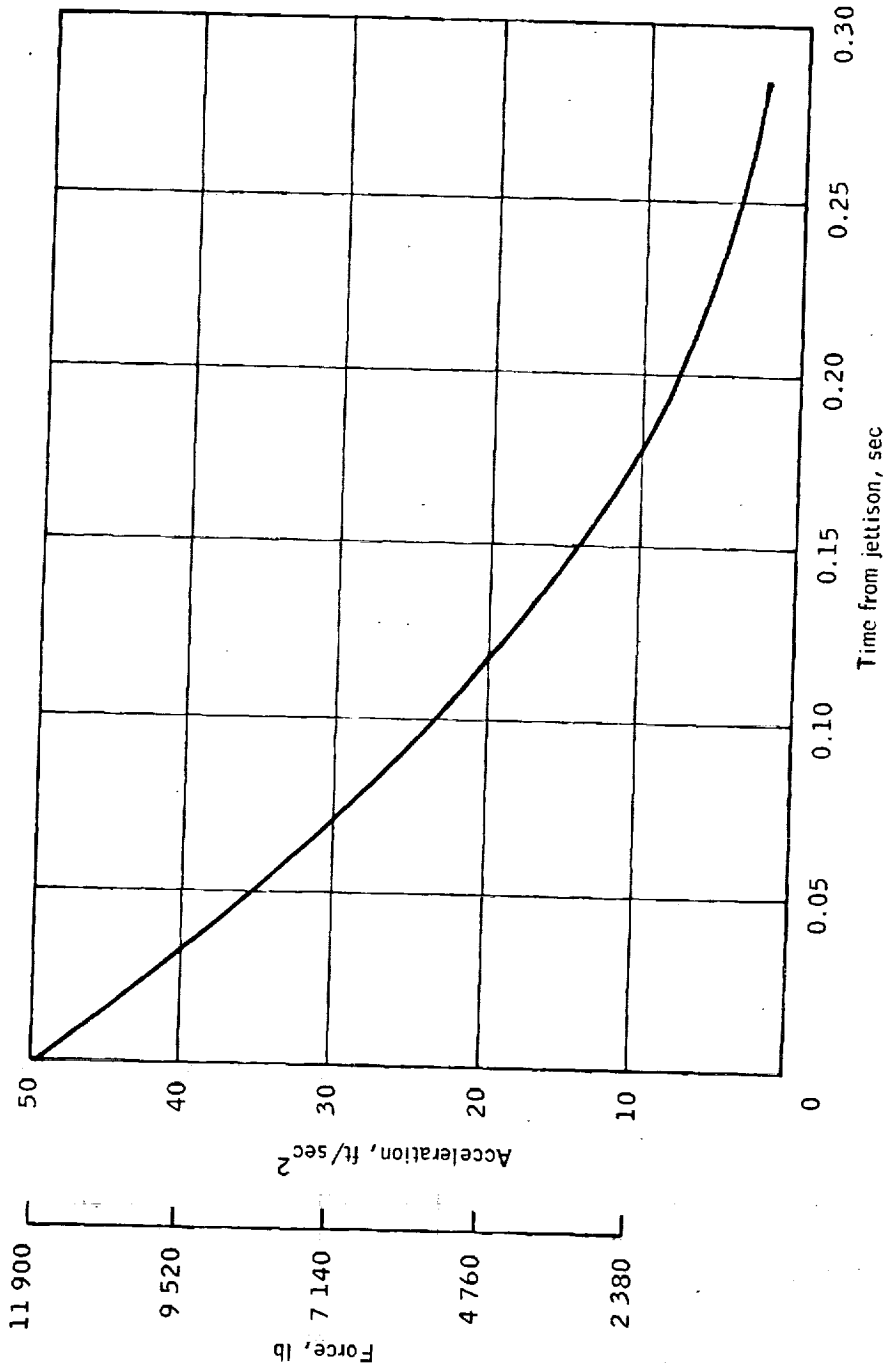
Figure 15-36.- Lunar module/command module relative acceleration after staging.

it completely. The remaining gap of about 1.4 square inches allowed a slight pressure decrease, as indicated by cabin pressure data. Figure 15-37 presents a history of hatch area that allows the cabin pressure to decrease rapidly and also yields an acceleration time history which agrees with figure 15-36.

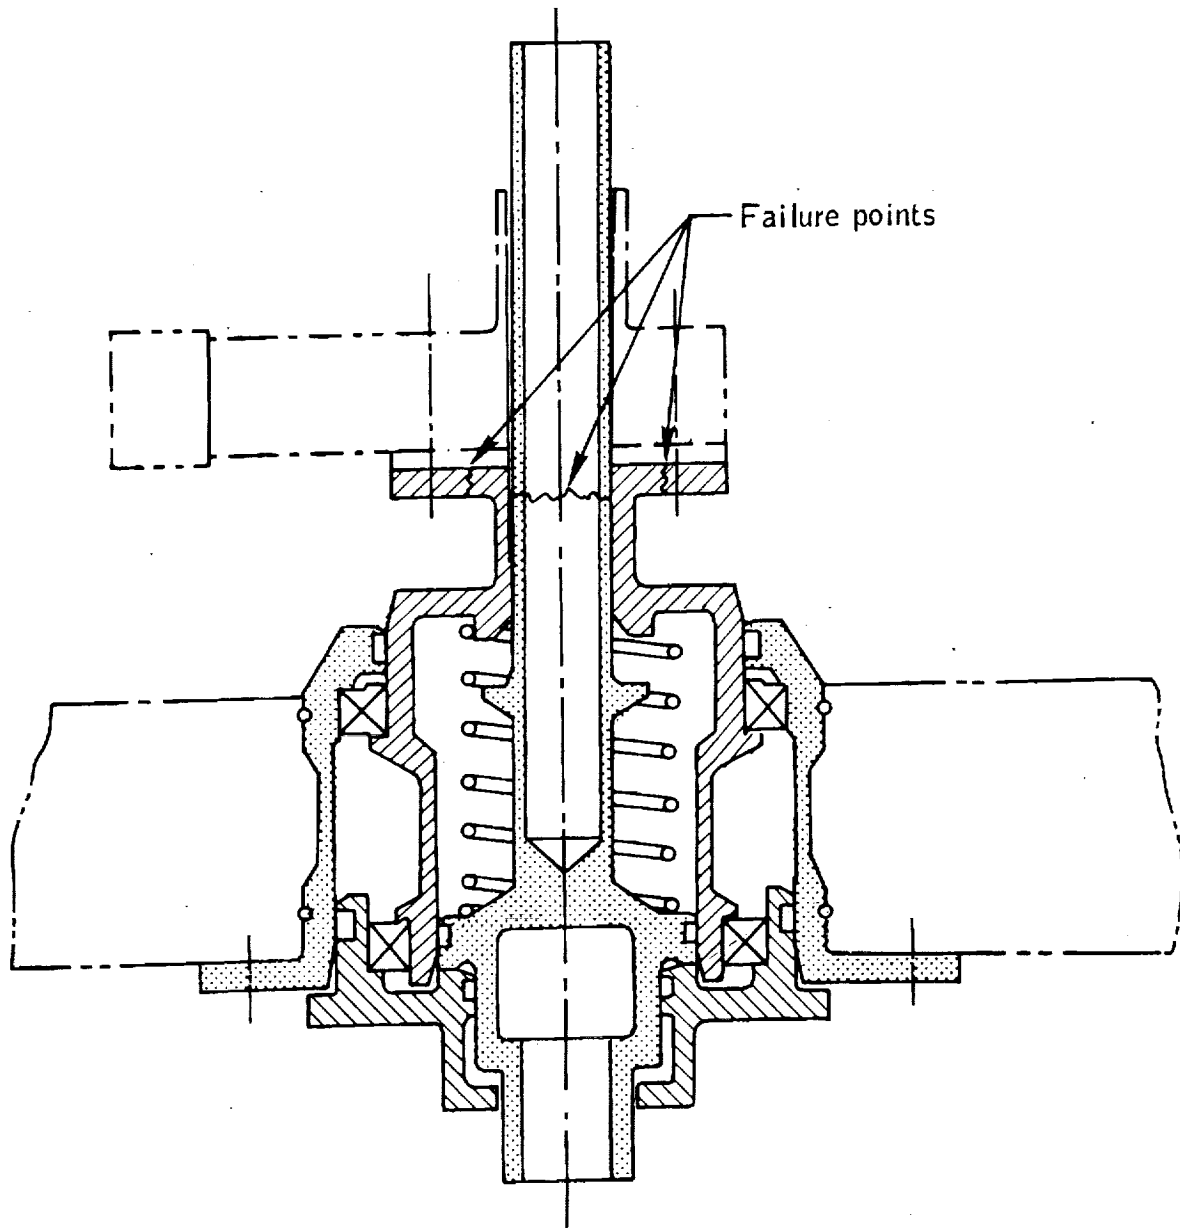
Figure 15-38.- Lunar module hatch latch.

The hatch and latch assembly was statically pressure-tested to failure. At a differential pressure of 4.1 psi, the latch failed as indicated in figure 15-38.

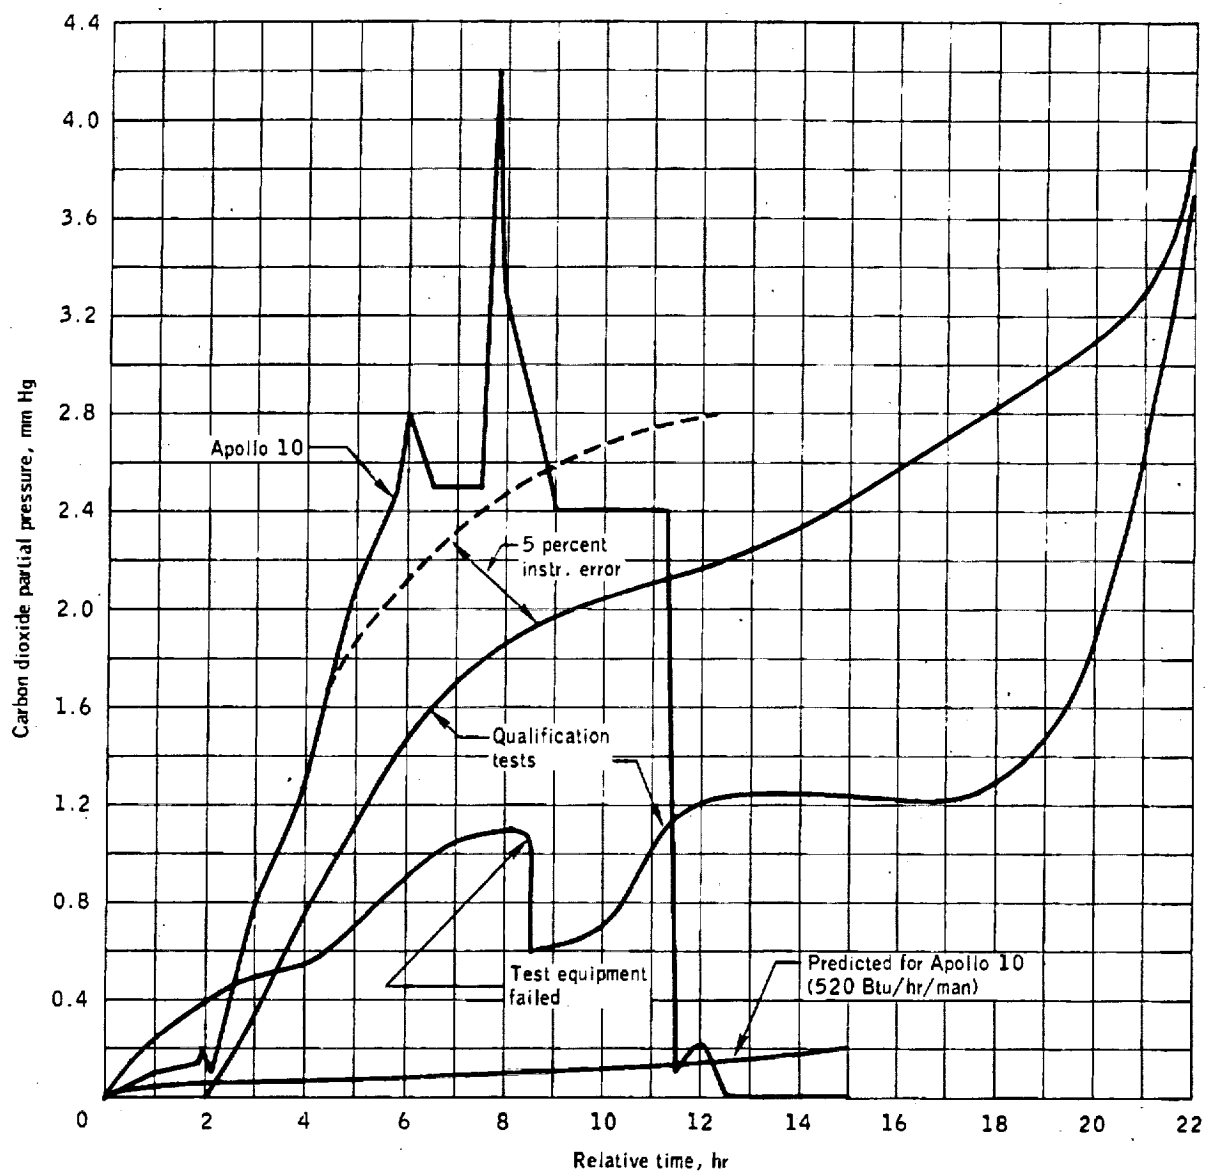
Figure 15-39.- Lithium hydroxide canister performance curves.

Two aspects of the indicated carbon dioxide level were considered anomalous. First, the rate of carbon dioxide increase from 97 to 101 hours exceeded the predicted by a factor of approximately 8. Secondly, the level remained constant for the next 5 hours (see fig. 15-39).

5. A qualification test cartridge exhibited a high rate similar to the flight data, except that the rate began to decrease at a lower level of partial pressure (fig. 15-39).

10. The carbon dioxide sensor tolerance is plus and minus 10 percent of full-scale voltage output. Superimposing a 5-percent tolerance on the qualification performance curve will approximate the flight data, as shown in figure 15-39.
